# RESUME

**On the fact of the investigation of the accident with the Mi-8MTV-1 helicopter RA-25114 at the Anapa airport on 26.09.2017.**

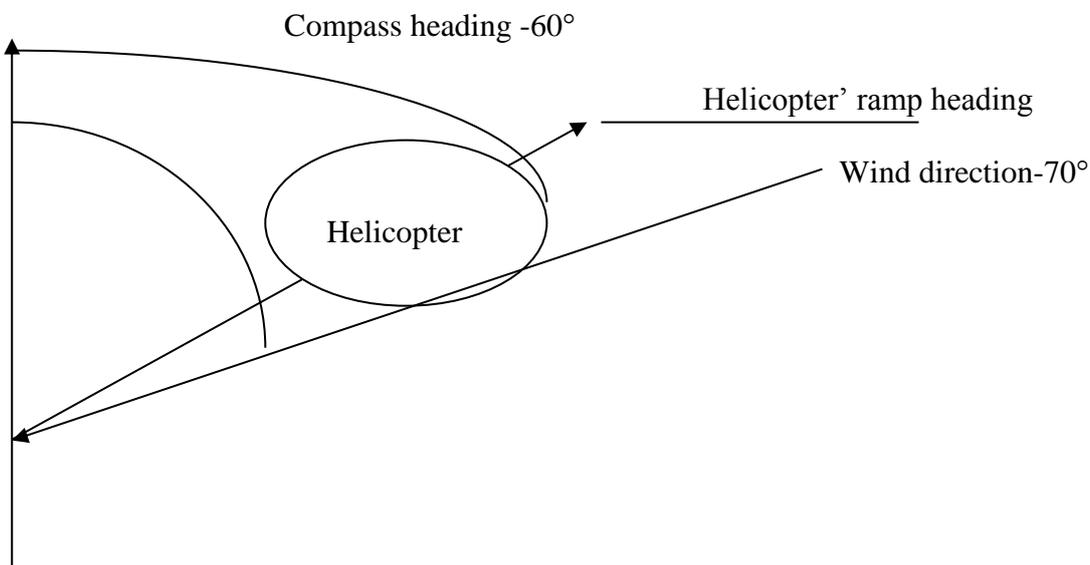
The wind direction relative to the helicopter is the angle between the longitudinal axis of the helicopter and the direction from which the wind is blowing (meteorological wind).

The course of the helicopter is the angle between the north direction of the magnetic meridian and the longitudinal axis of the helicopter. For the start-up engines the helicopter allocated with the magnetic course of MK-60°. The wind direction according to actual weather at start-up was 70°, the force of the wind, taking into account gusts at the time of the start-up, was approximately 19 m/sec. that is, opposite-lateral at the angle of 10° to starboard.

The wind speed in actual weather is taken into account gusts; in the forecast - without taking into account gusts of the wind. Therefore, it turns out that the helicopter engines were launched in accordance with Mi-8MTV-1 Flight Manual without violating the wind restrictions.

Therefore, parking the helicopter **“against the wind with the course of about 60°”**, as the commission writes **“to ensure a stable launch in a strong wind”** is completely contrary to the text of the operation documents of the helicopter (“Mi-8MTV-1 Flight Manual” and “PANH” Flight Operations Manual”).

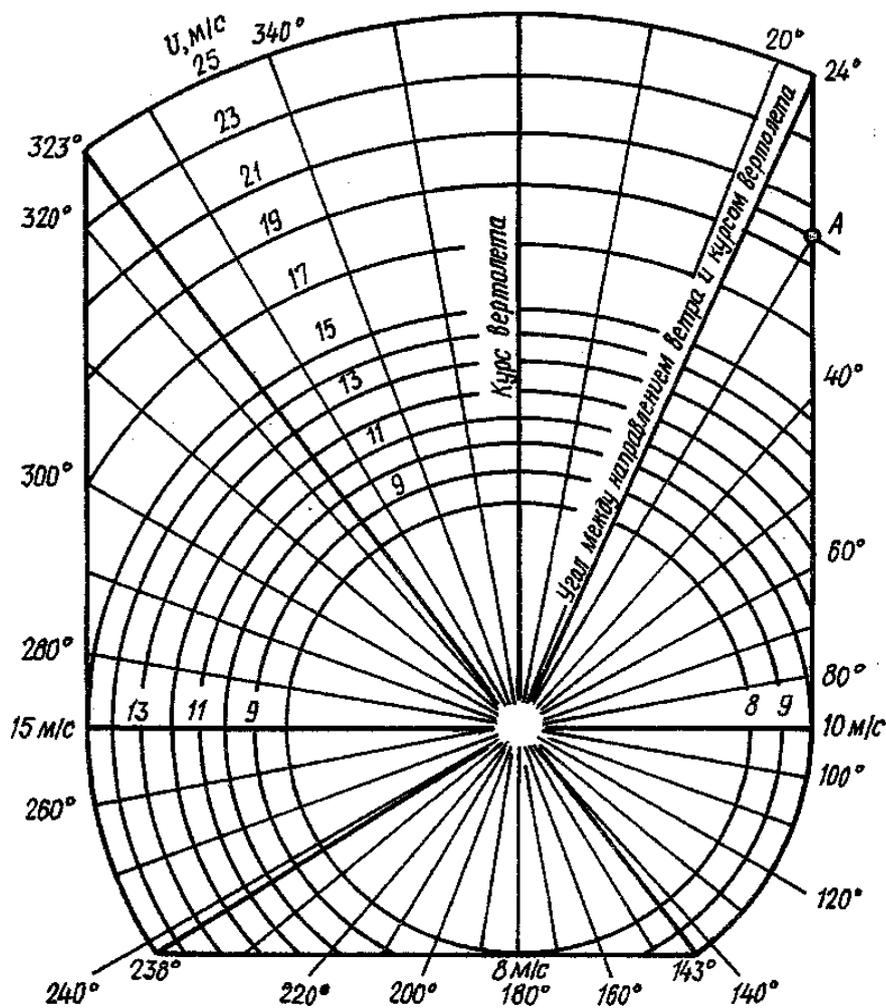
**The maximum wind speed depending on its direction relative to the course of helicopter during spinning, stopping the main rotor and taxiing reflected in the diagram below (Exhibit D-18):**

**Example:** At wind direction 30° from the right side the maximal wind speed consist of 20 m/sec, point A.

Thus, the position of the helicopter at the start of the engines ensured a steady startup of its engines in the conditions of the strong wind of 20-21 m/sec. I.e. parking the helicopter against the wind before start-up of its engines is the most correct solution.
